SPECIALTY CELLULAR – BOTTOM UP/TOP DOWN BILLOWS WHEN TOP DOWN PORTION IS LOWERED

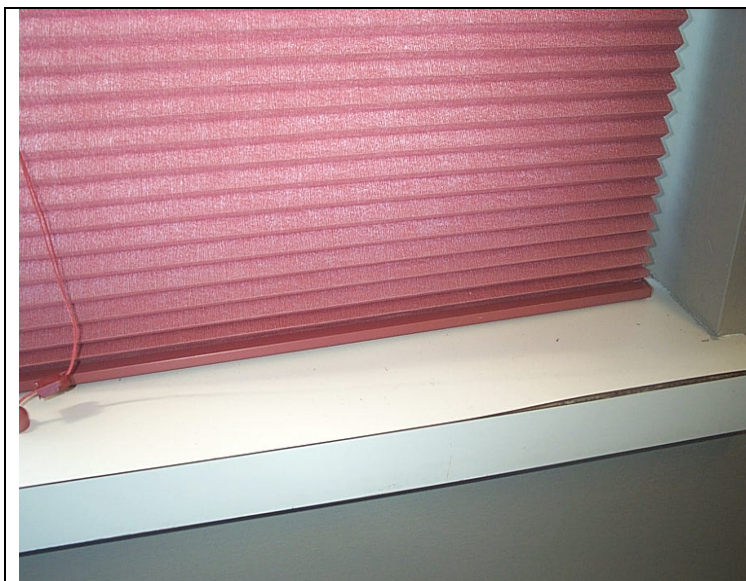
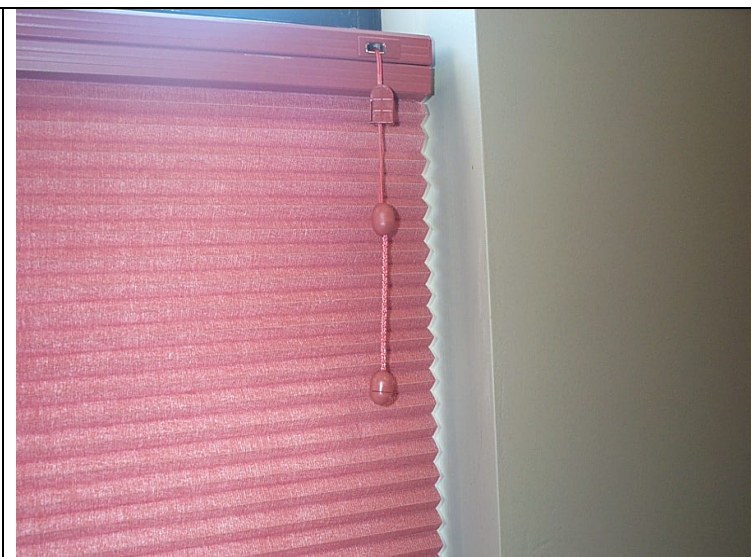
Possible Cause:

1. The Bottom rail is resting on the sill.

Solution:

1. Raise the bottom rail 1/16" off the sill, then try lowering again.
